METALS HANDBOOK

VOL. 9
FRACTOGRAPHY AND ATLAS OF FRACTOGRAPHY

8th EDITION

Fractography and Atlas of Fractographs

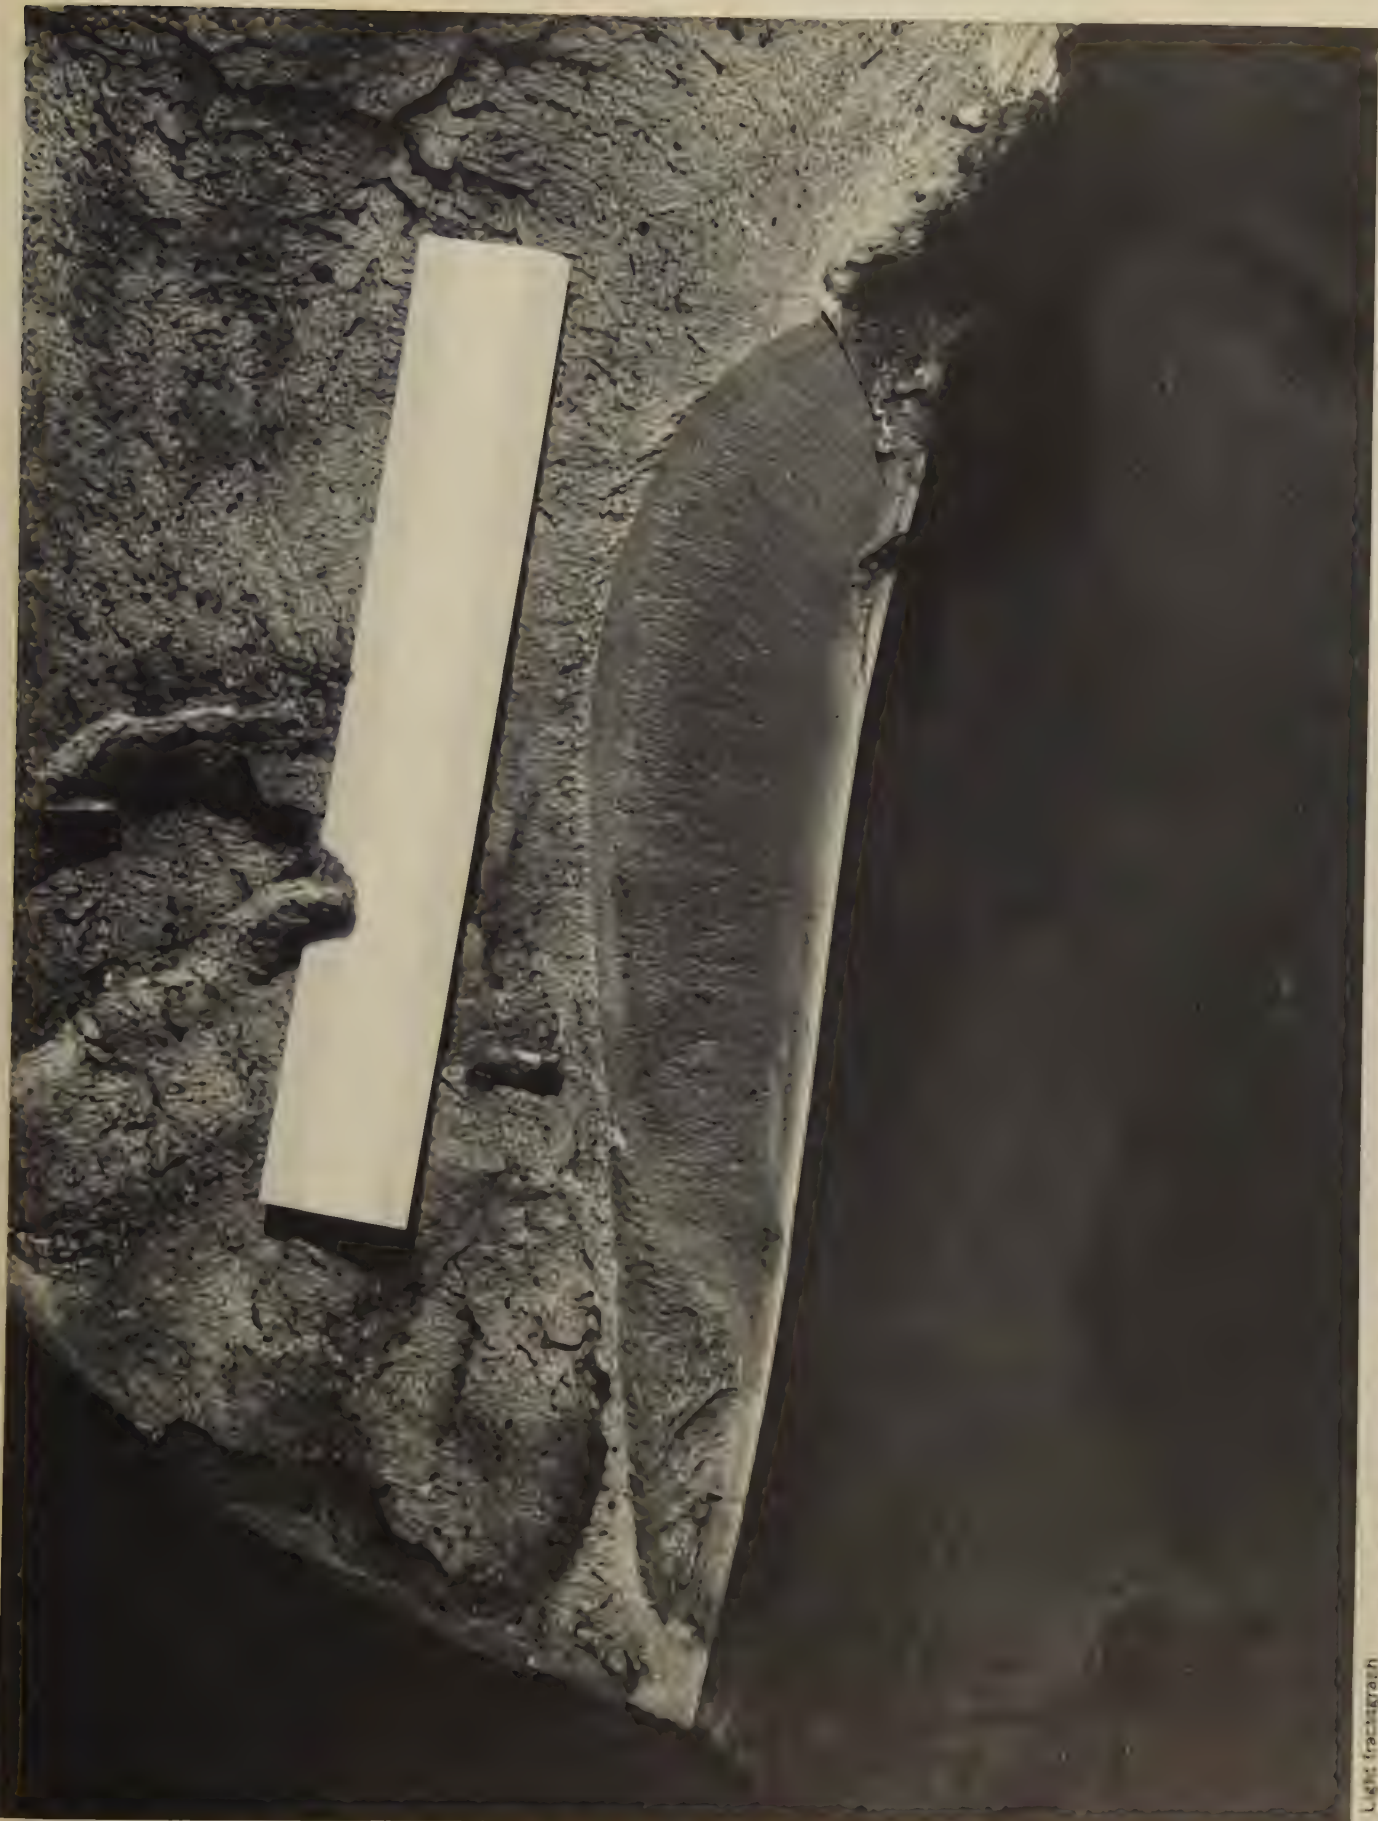
4876 Enlarged view of the fatigue zone of the 1045 steel blooming-mill-spindle fracture shown in fractograph 4875 (opposite page). Note the radial marks originating at the surface of the jaw. A few beach marks are faintly visible at the top edge of the fatigue zone. Note the sharpness of the terminating edge of the fatigue zone, at the transition to final, fast fracture. Note also the tongues of metal near the rule in the zone of final, fast fracture.

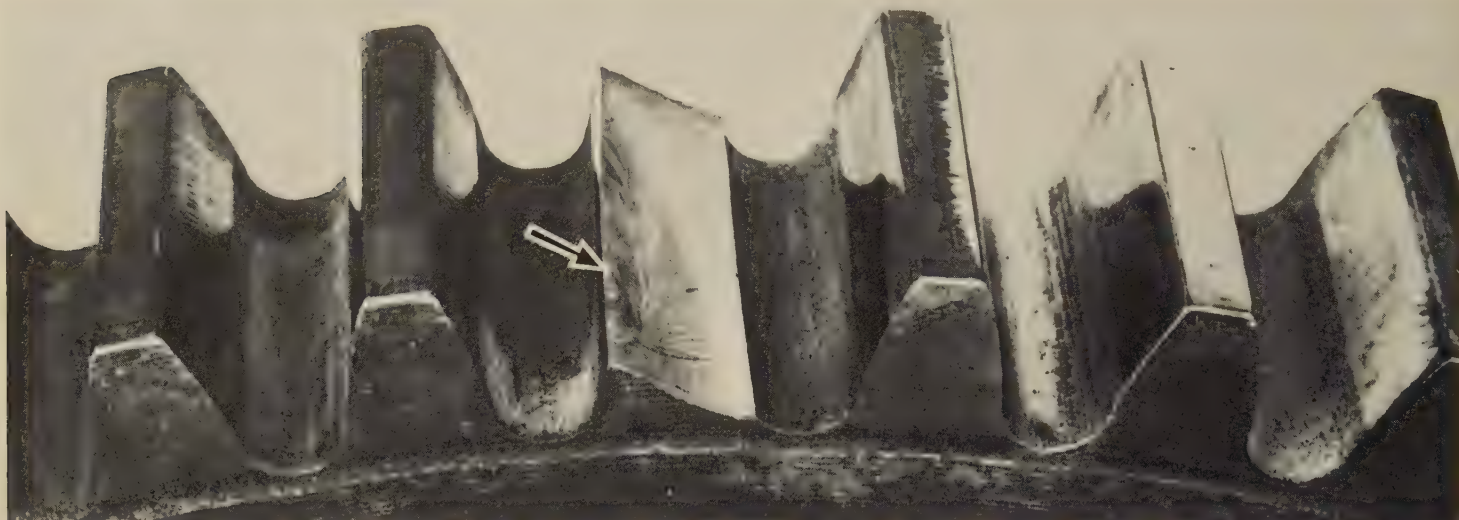
4877 A bending-fatigue fracture in a $\frac{7}{8}$ -in. constant-mesh transmission gear of 1045 steel, induction hardened to Rockwell C 55 at the surface. The arrow indicates the crack origin at the left edge of the fracture, where a small pit existed near the base of the contact area on the pressure side of the tooth. See also fractograph 4878, below.

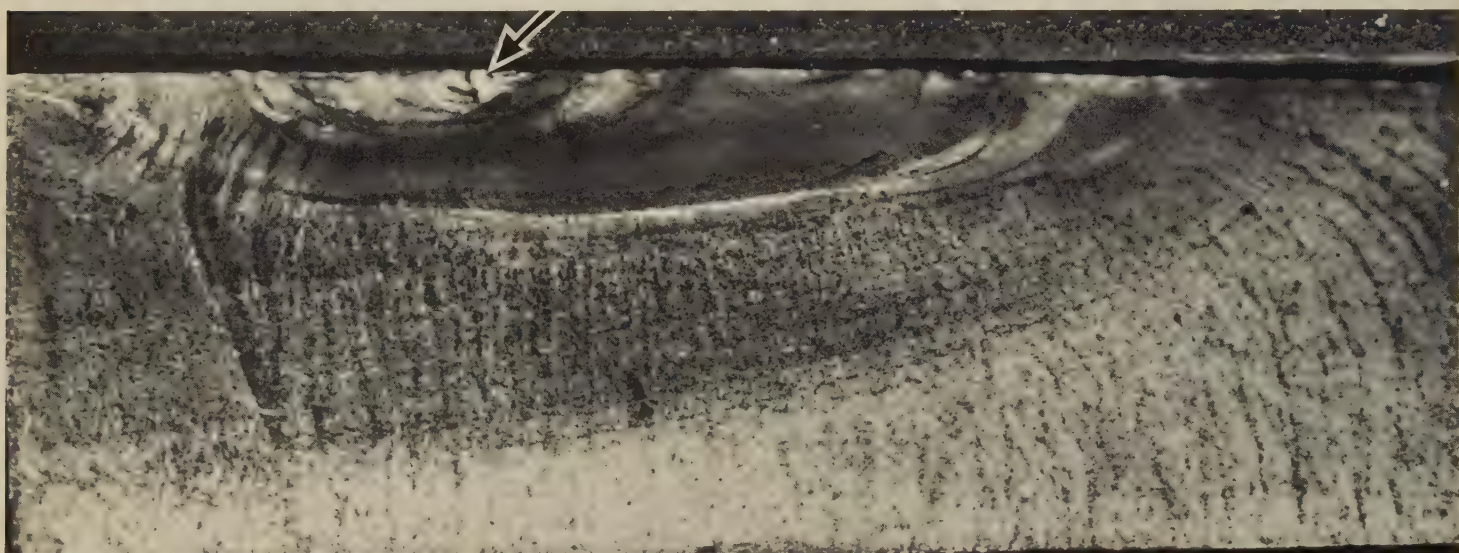
4878 A view of the fracture surface of the broken gear tooth shown in 4877, above. The area immediately adjacent to the crack origin (at arrow) is well rubbed, which indicates that the crack progressed slowly at first. The loading apparently was fairly well-distributed, although the crack grew somewhat more rapidly toward the left.

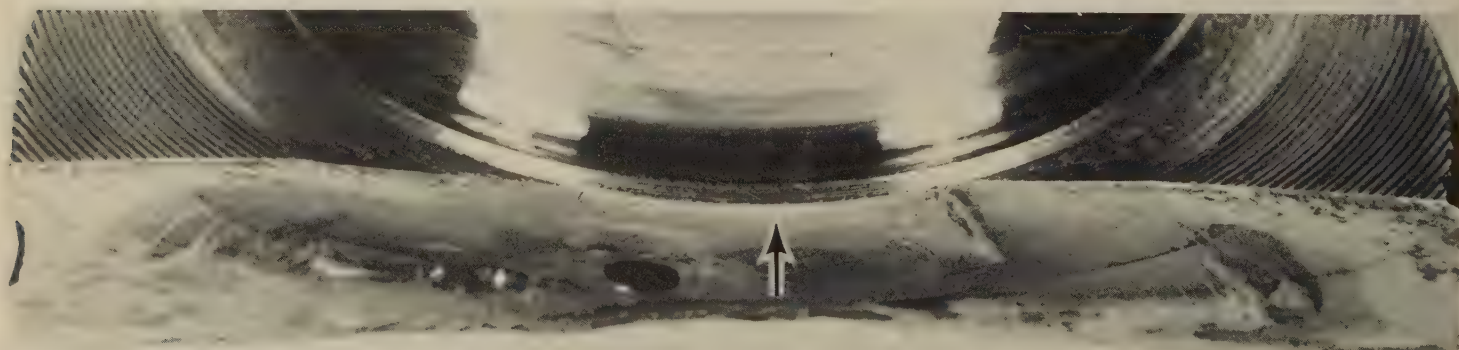
4879 A bending-fatigue fracture originating at a stress concentration in a fillet of a crankshaft of 1045 steel. The fillet was poorly shaped and contained a sharp tool mark. The crack started at the point marked by the arrow and followed the tool mark for some distance in each direction.

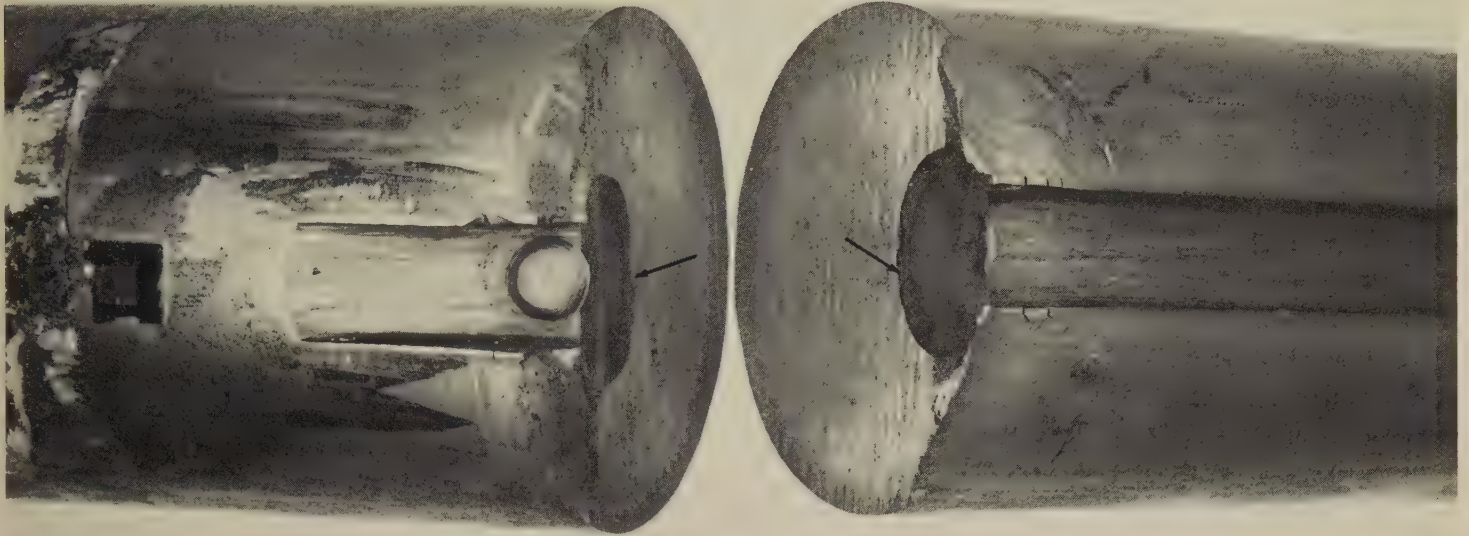
4880 A view of the mating surfaces of a fatigue crack (dark areas) exposed by sectioning a 1045 steel shaft quenched and tempered to a hardness of approximately Rockwell C 40. The crack, which was discovered before it could penetrate the entire cross section of the shaft, originated at a weld deposit that served as a stop in a keyway. 1 $\frac{2}{3}$ ×

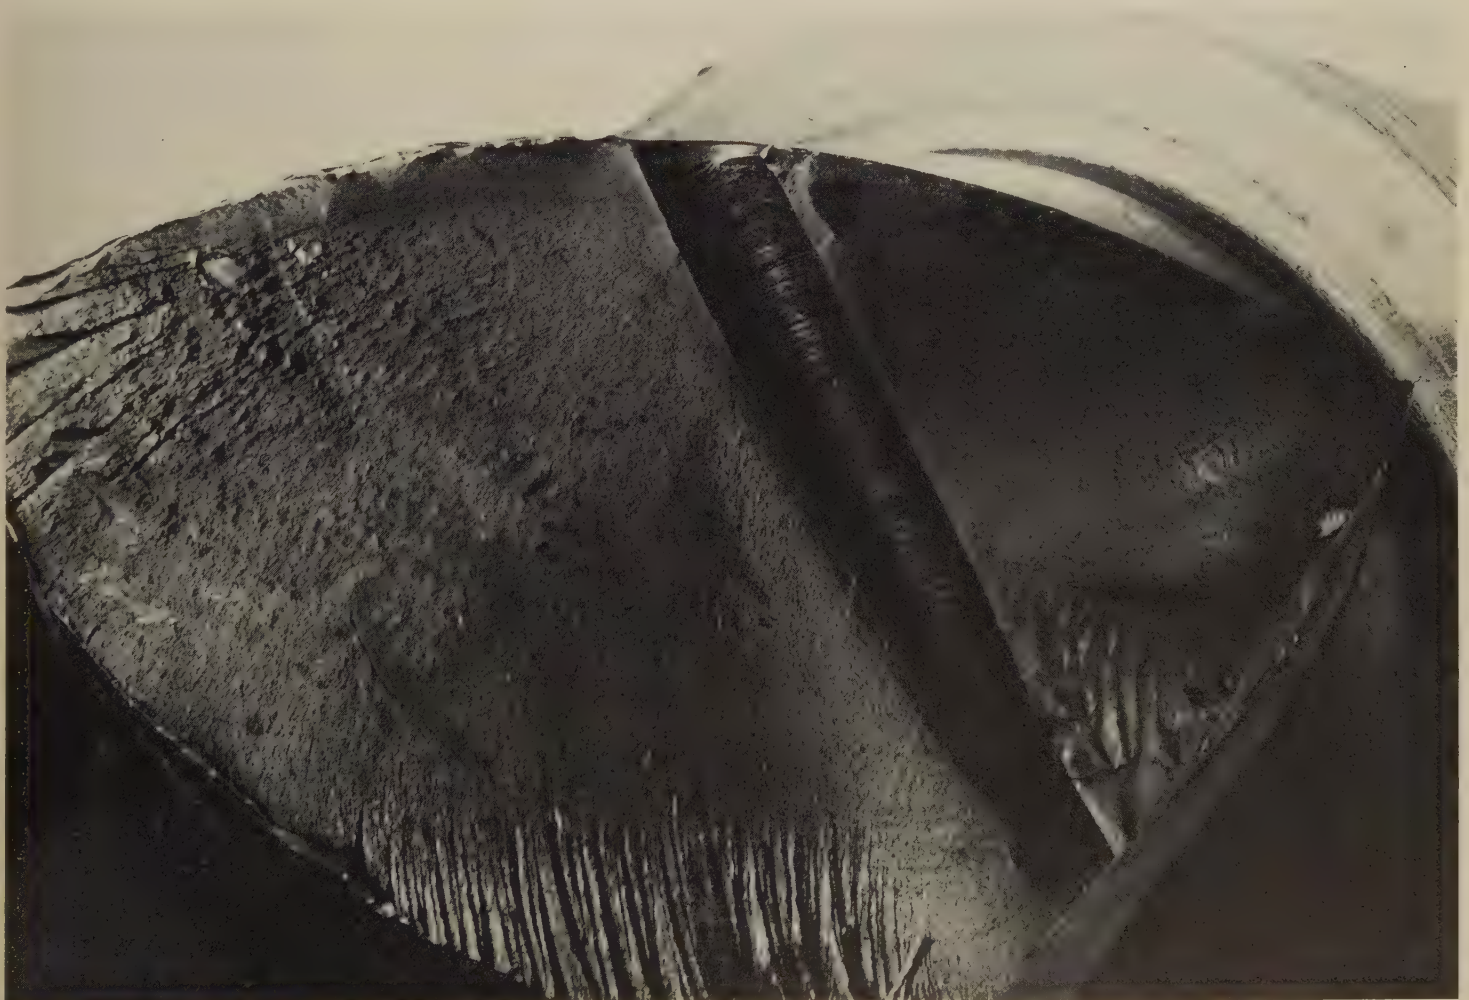
4881 Surface of a torsional-fatigue fracture in a 1045 steel crankshaft induction hardened to Rockwell C 55. The crack originated at the edge of an oil hole. Although it is not clearly evident in this view, the crack grew at a 45° angle to the axis of the crankshaft because of tensile-stress components caused by the torsional loading. About 2 $\frac{1}{2}$ ×

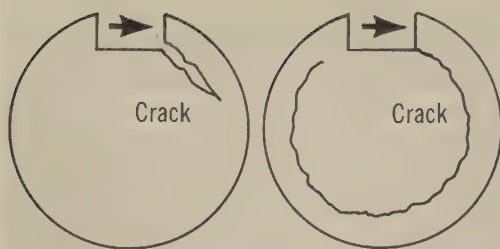
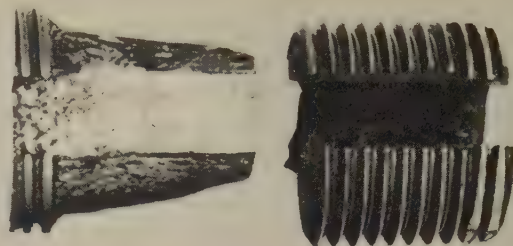
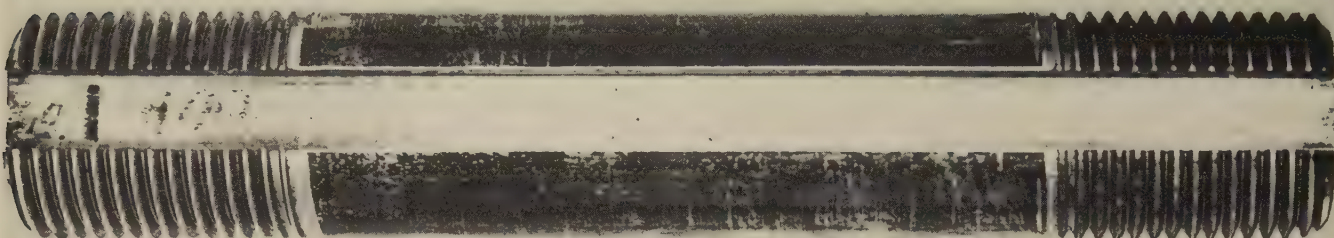
4882 At top right are the mating segments of a keyed shaft of cold drawn 1045 steel that was broken by fatigue, resulting in a "peeling" type of fracture; a complete shaft is shown at bottom. The fatigue crack began in the bottom corner of a keyway in which, because of a loose fit, the key transmitted nearly all the torque. The fracture progressed in shear parallel to the shaft surface, as shown at top left, traveling completely around the shaft.

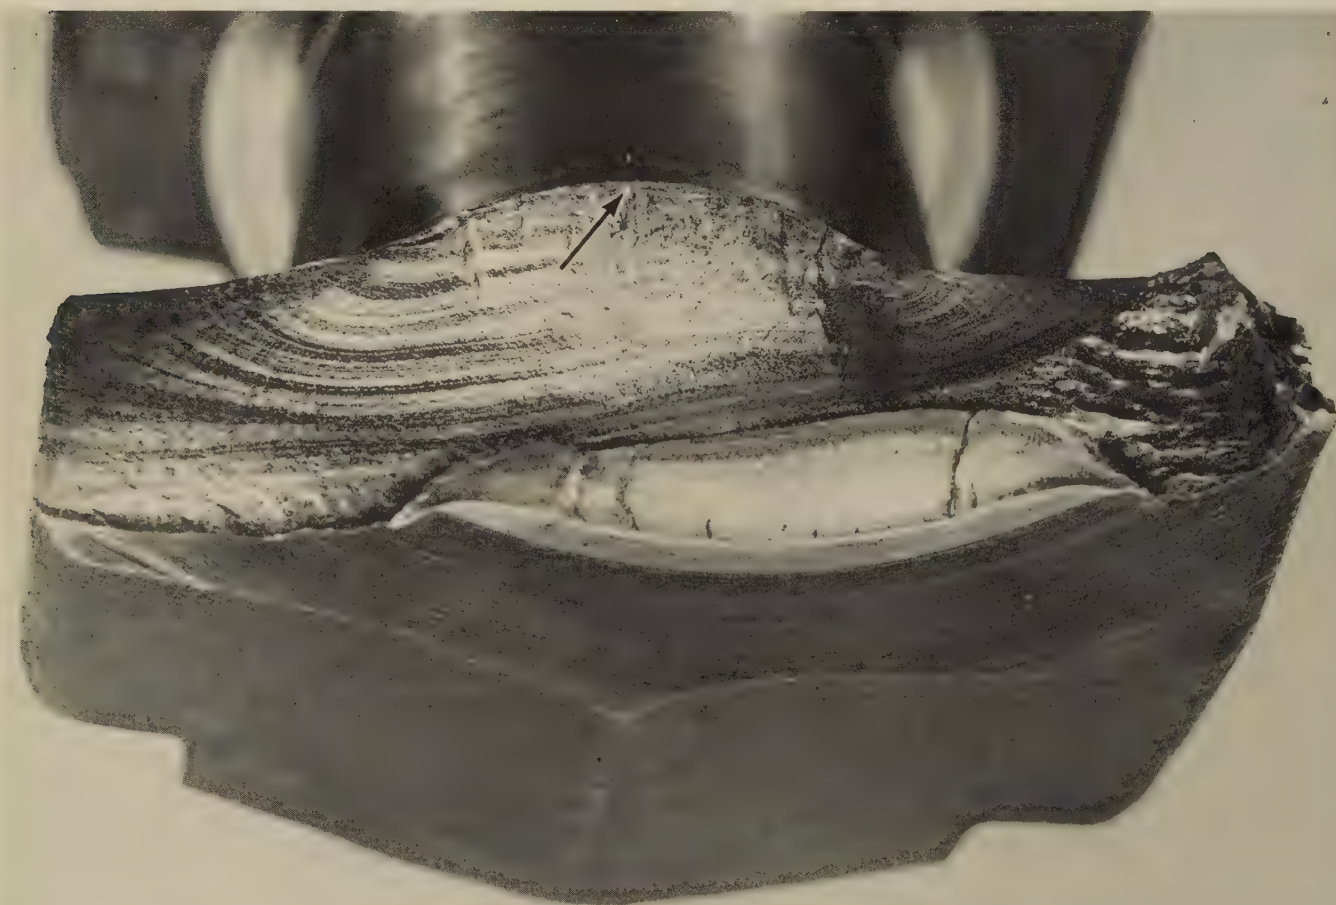
4883 Surface of a fatigue fracture in a crankshaft of 1046 steel with a hardness of Rockwell C 25 in the region of fracture. Two cracks were generated under a bending stress; one crack started in the journal fillet at the arrow and progressed through the cheek until it met the second crack, which began in the fillet on the opposite side of the cheek. Note the sharply defined beach marks in the upper portion of the fracture surface.

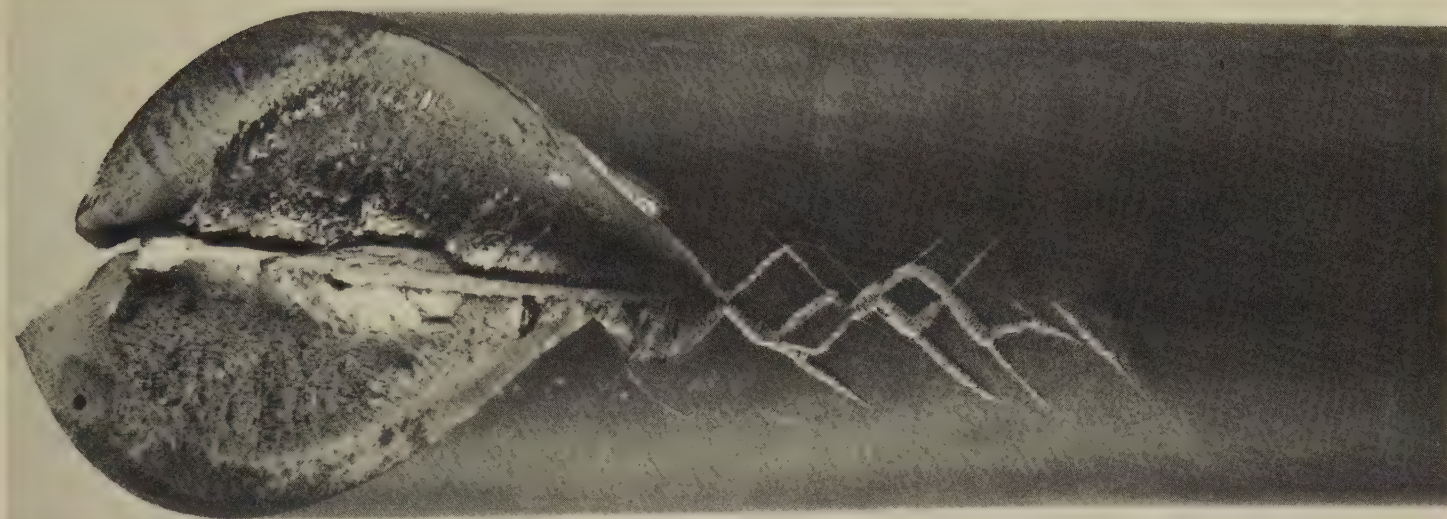
4884 Fatigue fracture in a 1.5-in.-diam axle of 1045 steel induction hardened and tempered to Rockwell C 52 and tested in reversed torsion, showing fatigue cracks on the diagonal planes of maximum tension stress. Secondary cracks revealed by the iron-powder patterns on the axle, which was magnetized, are symmetrical, indicating that the stresses applied during the test were fully reversed.

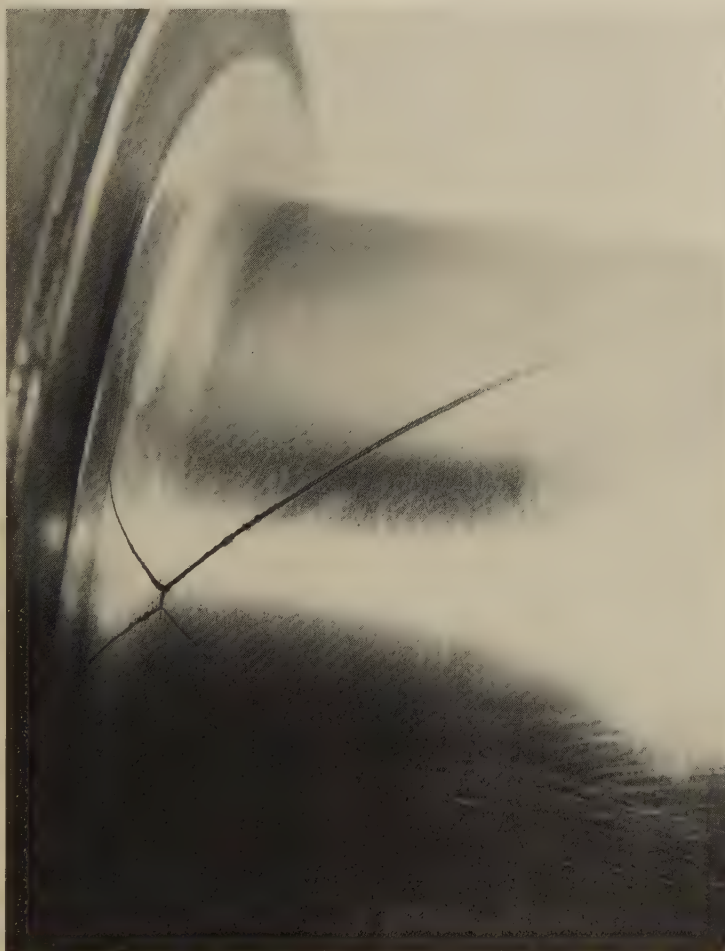
4885 Fatigue fracture in a 1045 steel crankshaft, with a hardness of Rockwell C 23, that was tested in reversed torsion. Visible at the base of a fillet is a fatigue crack that originated in the transverse direction (rather than in the longitudinal direction, as is most common) and that branched in four directions along the diagonal planes of maximum tension stress.

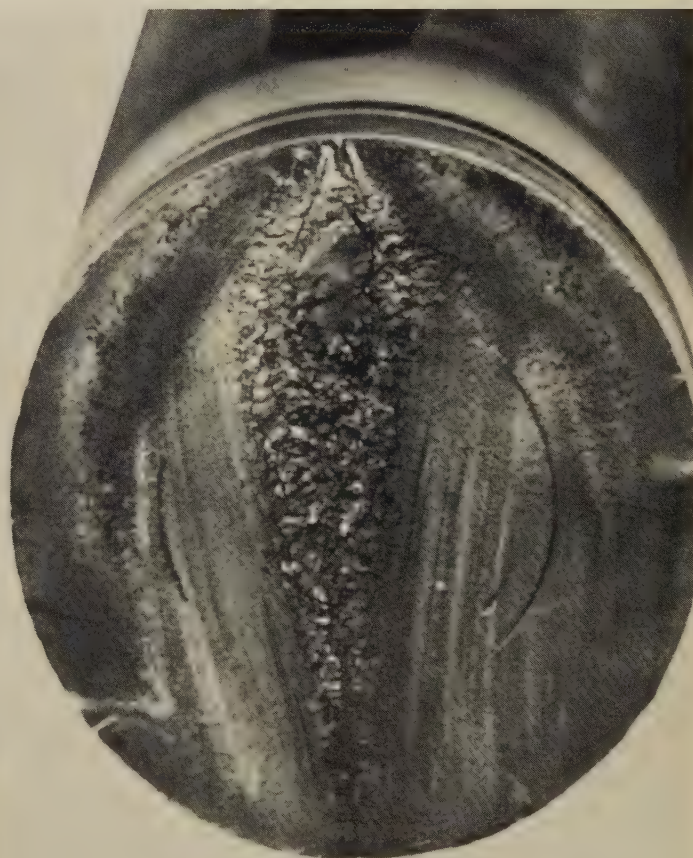
Light fractograph

4886 Surface of a fatigue fracture in a 1.6-in.-diam shaft of 1046 steel with a hardness of approximately Rockwell C 30. The shaft was tested in reversed cantilever bending. It is evident from the symmetrical fatigue pattern here that each side of the shaft was subjected to the same maximum stress and to the same number of load applications.

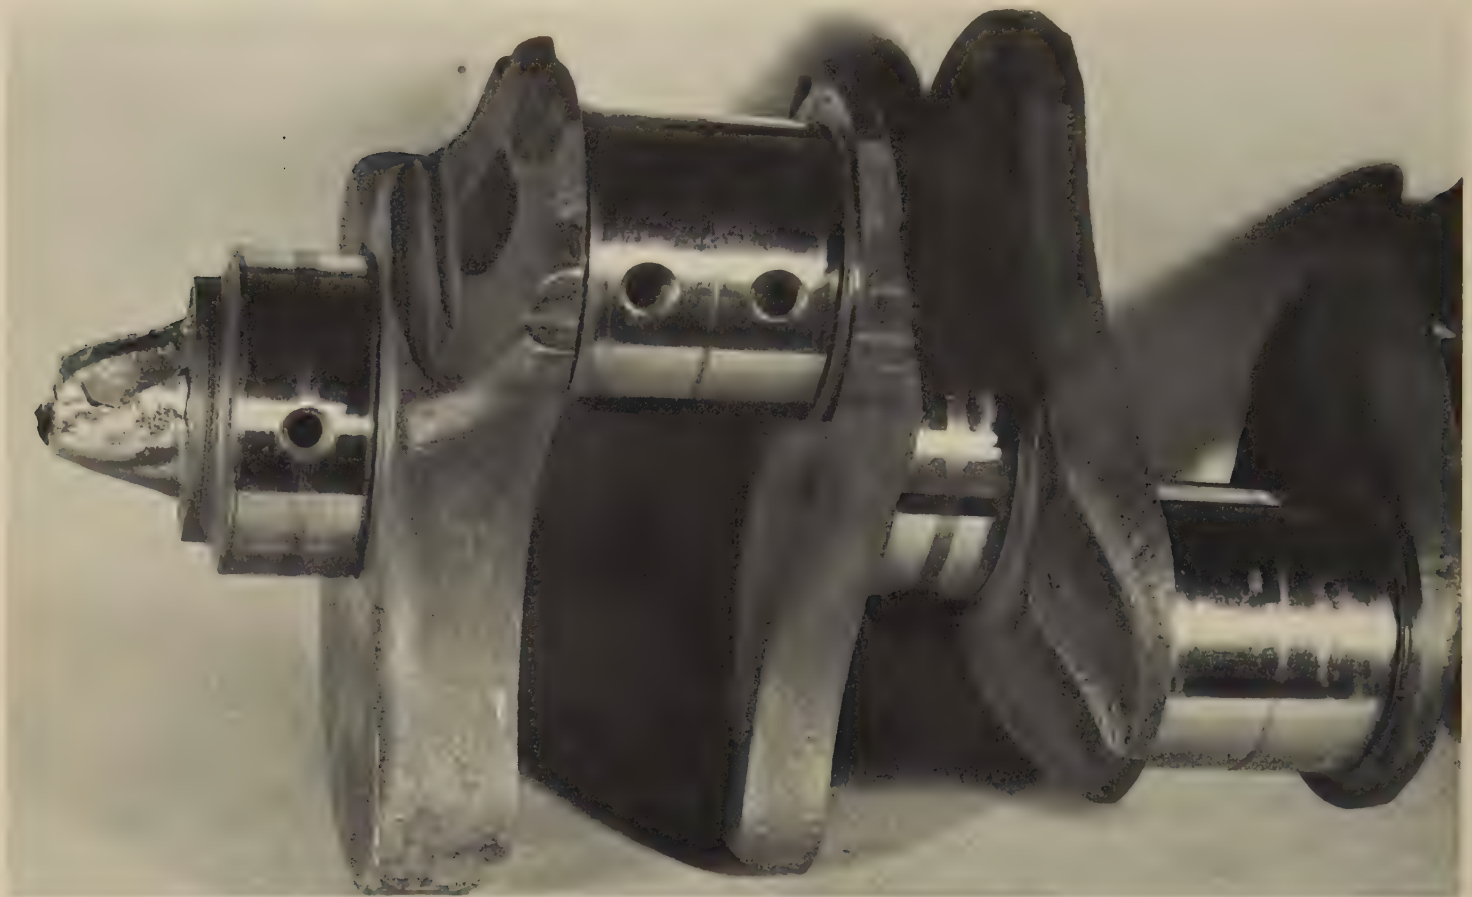
Photograph

4887 Marine-engine crankshaft of 1046 steel, quenched and tempered to a hardness range of 229 to 269 Bhn, that broke by fatigue at the timing-gear end, at left. The fracture surface, which is tapered, underwent severe battering at the time of final rupture. See also fractographs 4888 and 4889, below, for views of the fracture surface.

4888 End view of the tapered fracture surface in 4887, showing a counterbored longitudinal oil hole. Note the very rough machining marks and tears, which were sources of stress concentration.

4889 Higher-magnification side view of the tapered fracture surface of the crankshaft shown in 4887. Although the fracture surface underwent considerable battering during final rupture, the marks of progressive fatigue cracking are clearly evident.

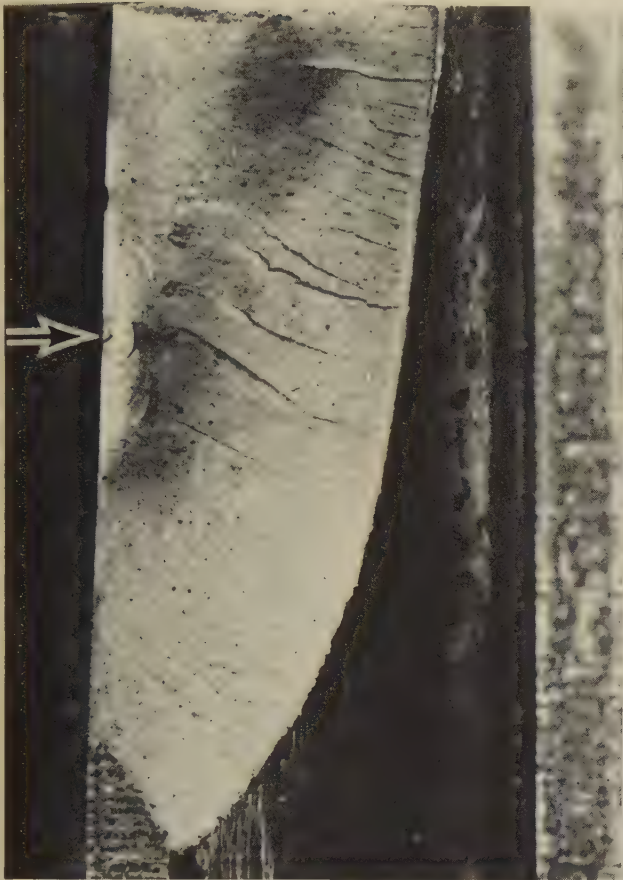
Light fractograph

4890 Surface of a fatigue fracture in a tooth of a 1050 steel gear with a hardness of Rockwell C 55. The fatigue crack originated at a forging defect (at arrow). Fatigue beach marks are visible near the fatigue-crack origin. Beyond these marks are the steps of a river pattern, caused by cleavage.

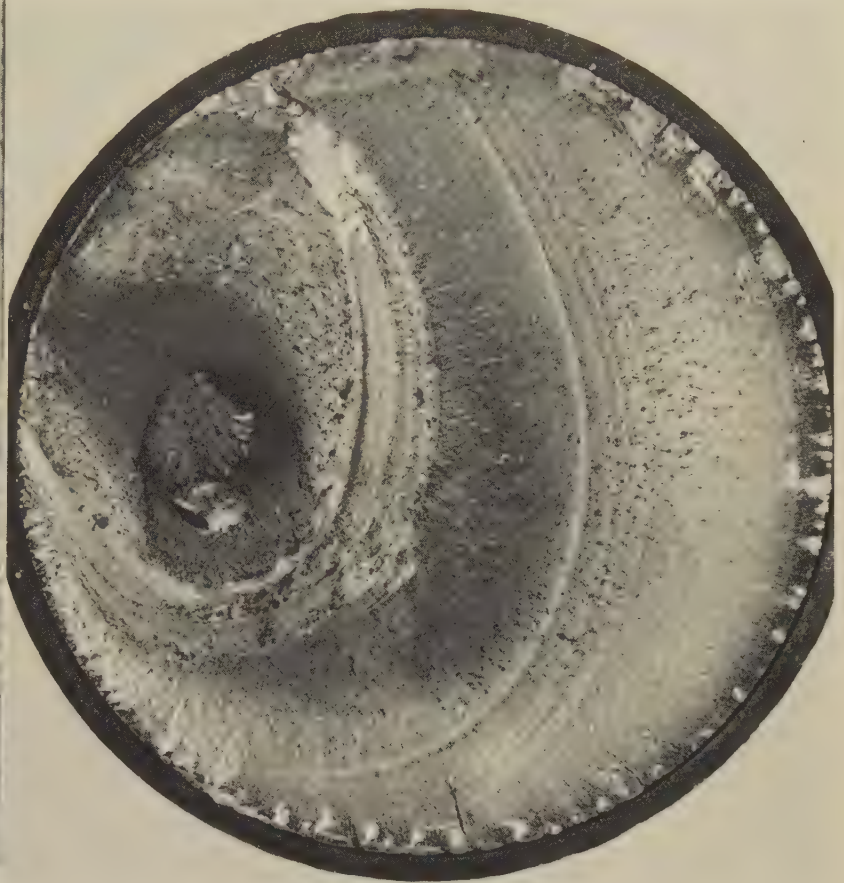
Light fractograph

4891 Surface of a fatigue fracture in a 1050 steel shaft, with hardness of about Rockwell C 35, that was subjected to rotating bending, showing ratchet marks indicating that fatigue cracks were initiated at many locations along a sharp snap-ring groove. Visible is an eccentric pattern of oval beach marks, the presence of which suggests an imbalance in loading.

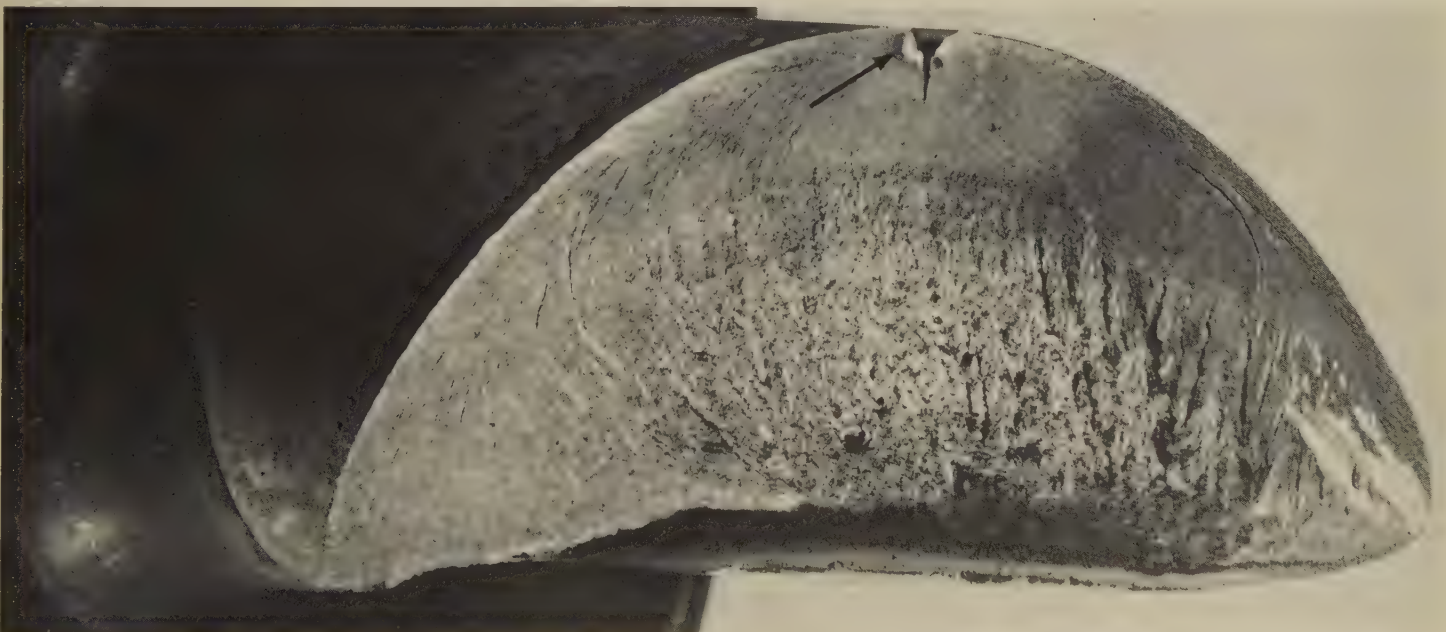
Light fractograph

4892 Surface of a fatigue fracture in a full-floating axle of 1050 steel induction hardened to about Rockwell C 50. The axle was tested in reversed torsion. The arrow indicates the origin of the fatigue crack, which grew by shear fatigue to the small, circular beach mark. Subsequent crack growth was by tension fatigue until final fracture (brittle tensile) occurred under a single torsional load.

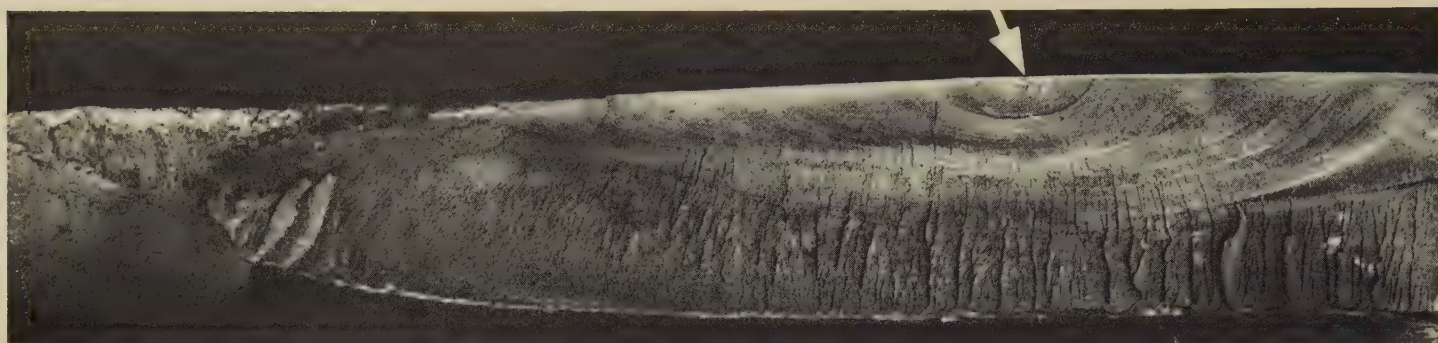
Light fractograph

4893 Surface of a fatigue fracture that occurred, after 732 hr of service, in a tooth of the induction hardened 1053 steel left-side bull gear of a tractor. Hardness of the tooth was Rockwell C 57 at the tip and Rockwell C 50 at a depth of 13.3 mm. Hardness in the root fillet was about Rockwell C 56 near the surface and Rockwell C 50 at a depth of 11.5 mm. The arrow indicates the origin of the fatigue crack. See also fractographs 4894, 4895 and 4896, below.

4894 Surface of a fatigue fracture (similar to that in 4893) that occurred, after 841 hr of service, in a tooth of the right-side bull gear of the same tractor. This gear also was made of 1053 steel and induction hardened. Hardness of this gear was similar to that of the gear in 4893 except that the depths at which hardness was Rockwell C 50 were 12.2 mm below the tip of the tooth and 9.5 mm below the surface of the root fillet. The arrow indicates the fatigue-crack origin. The damage to the tooth just below the one that fractured probably resulted from jamming by a fragment from the fracture.

4895 TEM replica of an area of the fracture surface of the left-side bull gear in 4893, taken near the fatigue-crack origin. Visible are several inclusions believed to have contributed to the formation of the fatigue crack. See 4896.

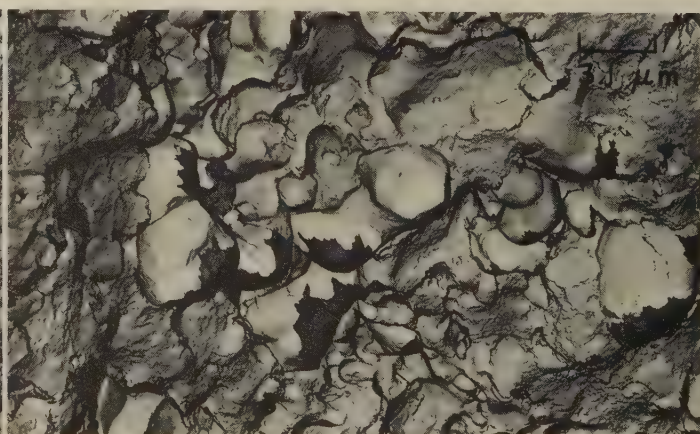
TEM fractograph (p-c replica)

4896 TEM replica of a portion of the area in 4895 (at left), but at higher magnification, showing the inclusions more clearly. Similar inclusions were found near the crack origin in the fracture surface of the right-side bull gear in 4894.

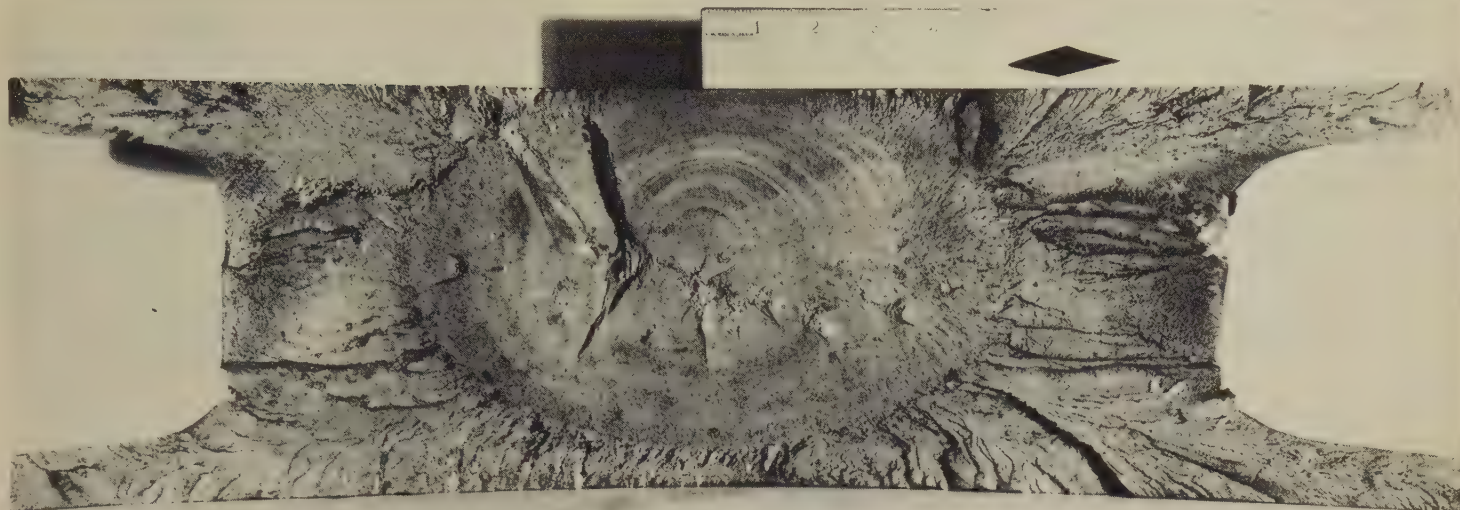
Light fractograph

4897 Surface of a fatigue fracture that occurred, after approximately one year of service, in a 1055 steel wheel of a 600-ton stripper crane. Visible in the center of the fracture is a fatigue zone showing beach marks that are concentric around the fatigue-crack origin, which evidently was an internal flaw approximately 1½ in. beneath the wheel-tread surface. The chemical analysis of the steel was 0.60% C, 0.82% Mn, 0.009% P, 0.024% S and 0.24% Si, which was acceptably close to specification. Note the chevron patterns in the area of final, fast fracture that surrounds the fatigue zone.

4898 Surface of a fatigue fracture that developed in the flange of a 1055 steel wheel of an open-hearth crane after nearly 20 years of service. The fracture surface was exposed by arc cutting the adjacent metal. This fatigue fracture, like the one shown in 4897 (above), was initiated by an internal flaw and propagated outward radially; no external defect was found to be involved in either this fracture or the fracture in 4897.

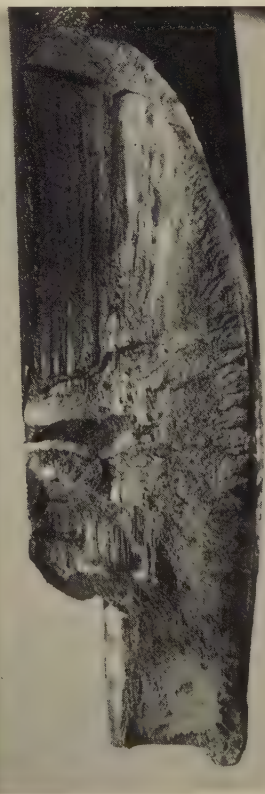
Light fractograph

4899 Complex fatigue fracture in 1060 steel spring wire, 0.18-in. diam, originating at two or more crack nuclei at and above lower shoulder at left edge.

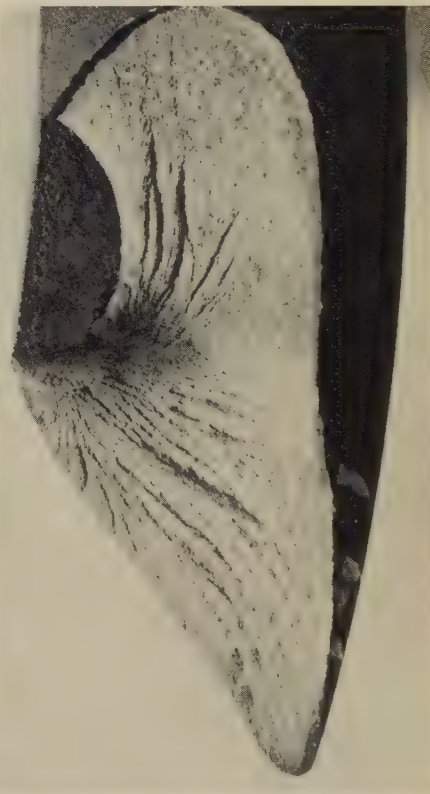
Light fractograph

4900 Surface of a fatigue fracture in 5/8-in.-diam spring wire of 1060 steel. The crack origin, which undoubtedly was a surface flaw, generated a fatigue zone (dark area at upper left). The fatigue crack grew very slowly, and beach marks became obscured by oxide.

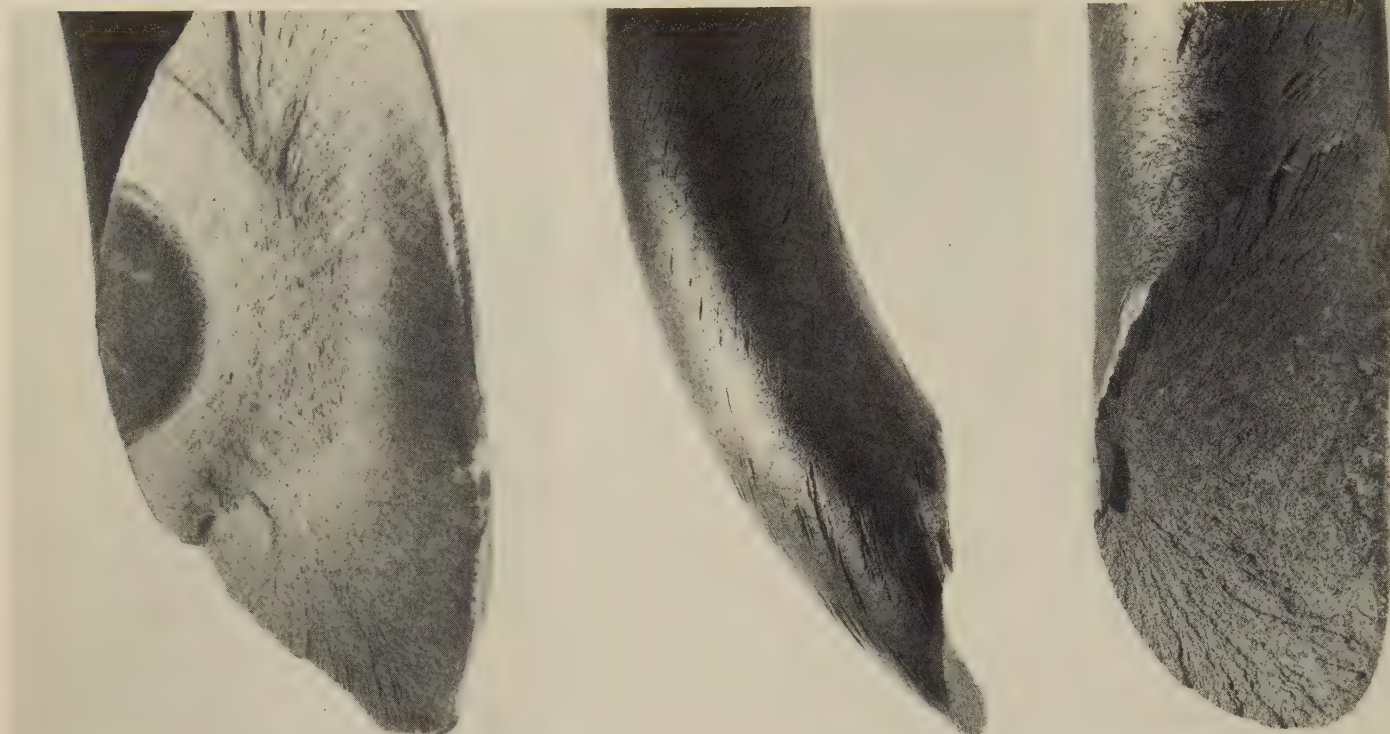
Light fractograph

4901 Fatigue fracture in a $\frac{5}{16}$ -in.-diam suspension spring of 10B62 (15B62) steel wire. The fatigue crack probably originated at a surface defect and grew so slowly that oxidation occurred (note darkness of fatigue zone at left).

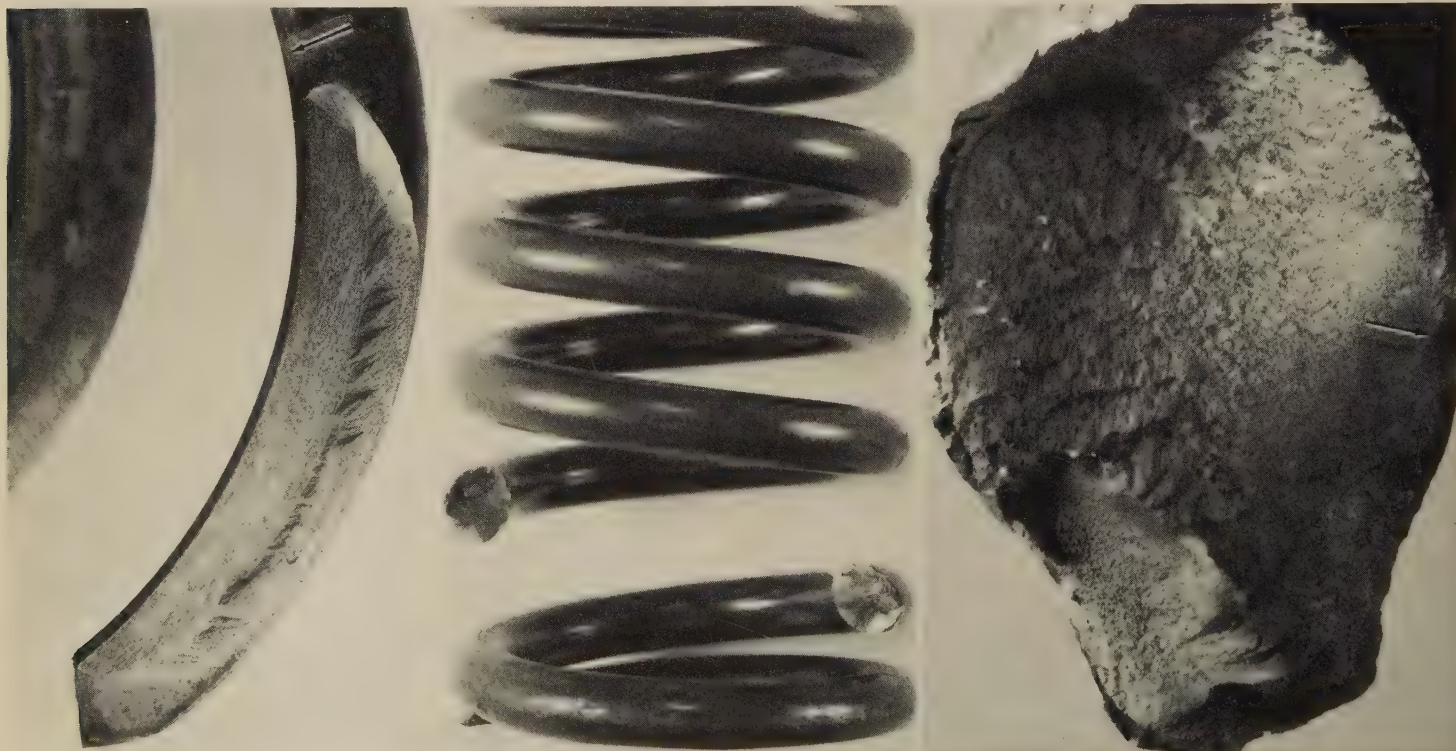
Light fractograph

4904 Fatigue-fracture surface of a suspension spring of 10B62 (15B62) steel wire with a hardness of 460 Bhn. Note the fine seam (at arrow), which is the fatigue-crack origin.

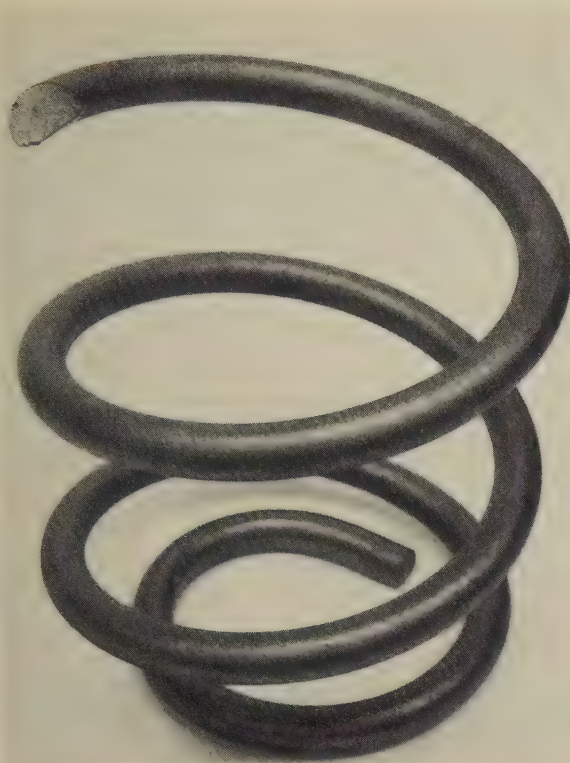
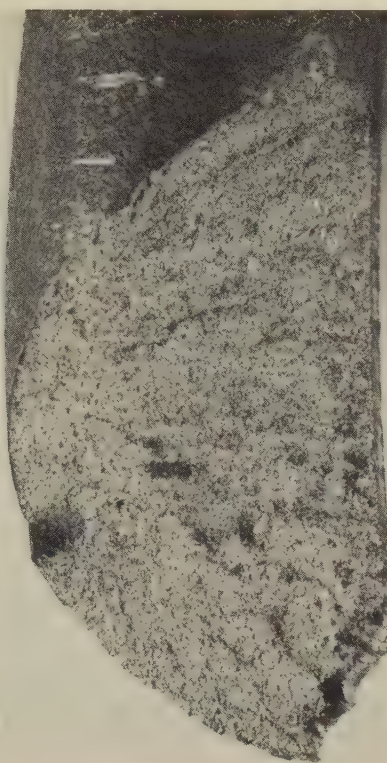
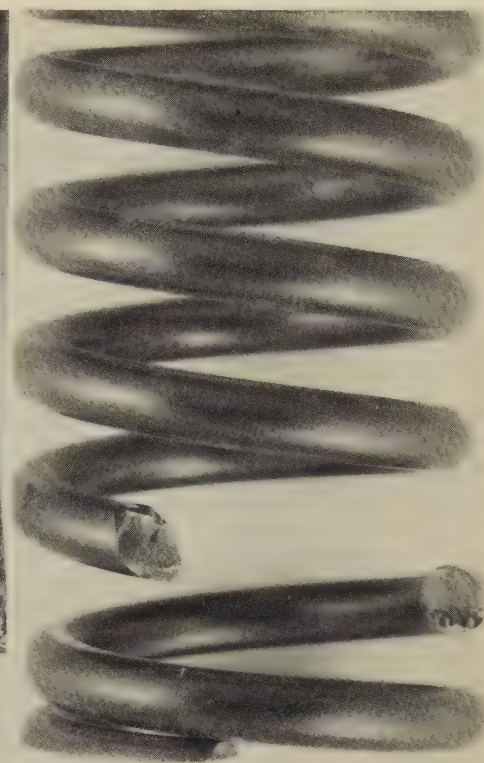
Photograph
4907 Fatigue-fractured spring formed from $\frac{3}{4}$ -in.-diam 1060 steel wire. The seam on the back side of the top turn enters the fracture surface at the dark spot at left edge. See fractograph 4908, at right, for a view of the fracture surface.

Light fractograph
4908 Fracture surface of the spring in 4907 (left). The fatigue-crack origin is at the seam at left edge. The surface of the wire was gouged after fracture.

Photograph
4909 Fatigue-fractured spring of 0.200-in.-diam 1060 steel wire (hardness, Rockwell C 43 to 48). This fracture, unlike that of the similar spring in 4905, originated at the surface (see 4910, at left below).
